Teardrop

Land Contamination Desk Study

Preliminary Risk Assessment - Feasibility Stage

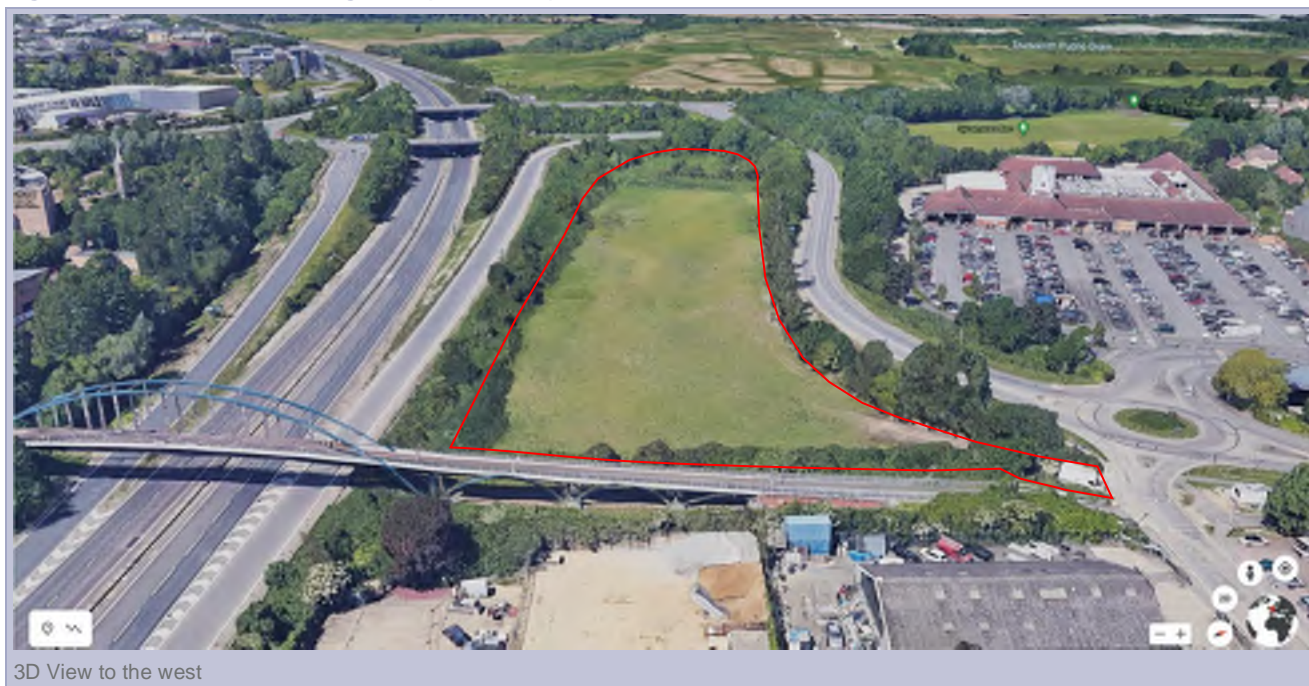
Figure 3 View of the site facing west (circa 2017)

The 1.88 hectare site currently comprises a relatively flat area of enclosed grassland, that is bound by vegetated road embankments to the north, south and west and the Jane Coston Cycle Bridge to the east (see Figure 3). The bridge provides cycle and pedestrian access over the A14. The site is accessed via a gated entrance in the northeast corner. Beyond the adjacent roads, the site is surrounded by the following land-uses:

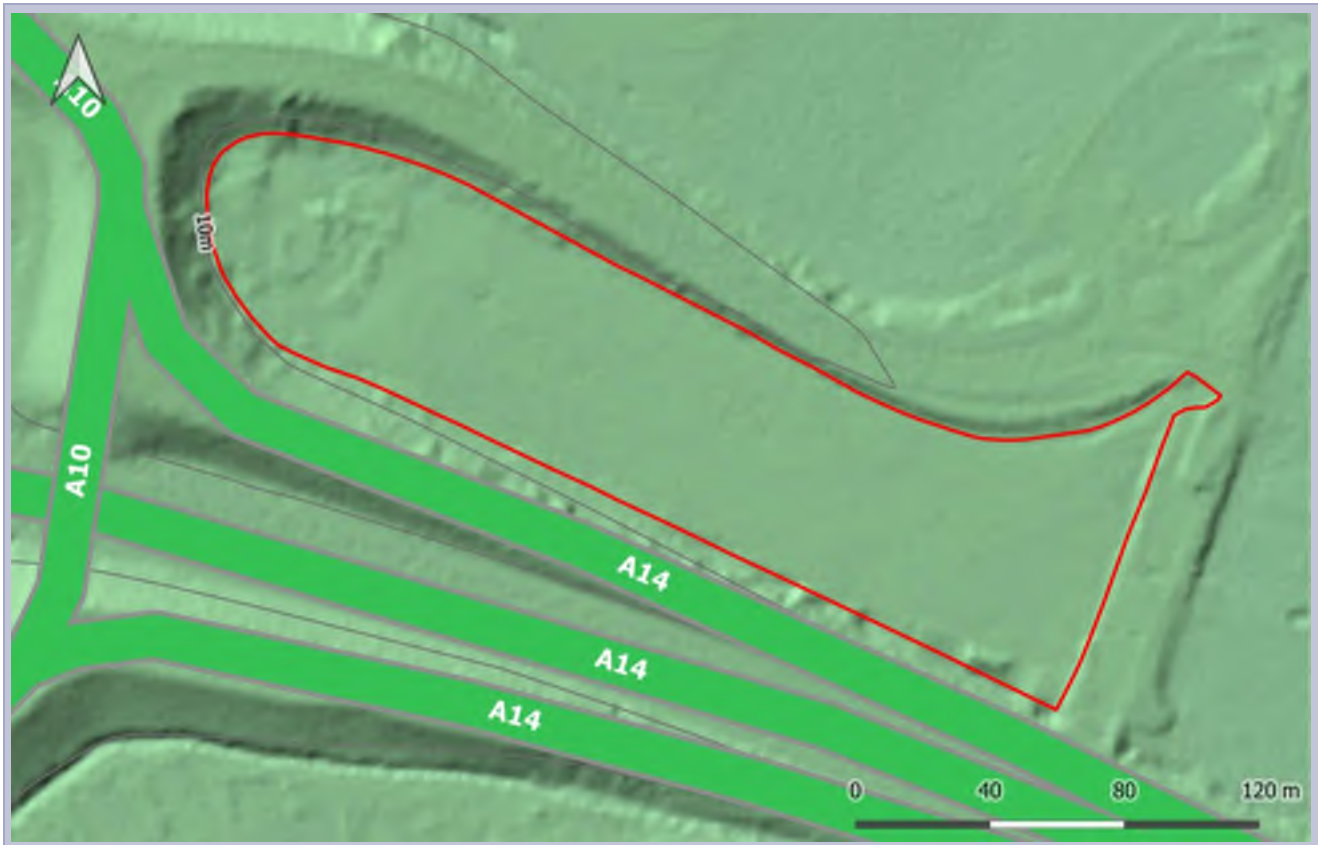
Figure 4 Site topography

Mapping indicates that the site is at an elevation approximately 10mAOD, as shown in Figure 4.

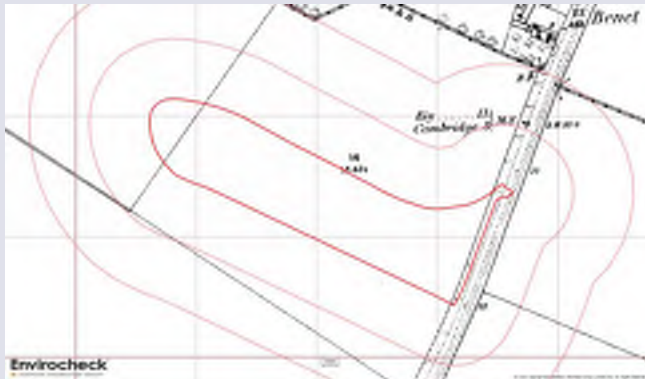
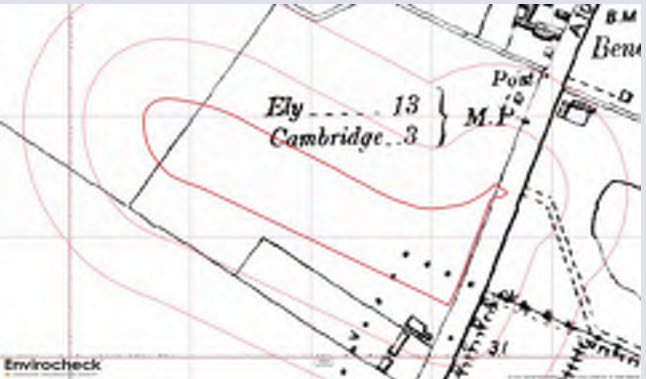
Figure 5 Site history

<p>1887-1909: onsite: the earliest maps from 1887 indicate that the site comprised agricultural fields, with most of the site within a single field adjacent to an un-named road along the eastern boundary. The western end of the site was located within a separate field.</p> <p>Offsite: the village of Milton is shown (850m NNE). Several surface water ditches are shown the nearest is labelled "Thirteenth Public Drain" flowing NW to SE (93m N). Benet Farm (120m N) and Rectory Farm (460m SW) are also shown. By 1903, a sewage farm is shown (160m SE) and the drain has been re-named Thirteenth Public Drain.</p>	<p>1927-1952: onsite: no notable changes</p> <p>Offsite: the Sewage Farm had extended to within 20m SW by 1927 and new buildings are shown 85m NE opposite Benet Farm (1927)</p> <p>A tile works (160m NE) and a note indicating 'Romano-British Pottery/Skeleton found AD 1903' (600m SE, within the sewage farm footprint) are shown in the 1938 map. By 1952, several potential 'gravel pits' are shown to the E (130m) and NE (350m).</p>

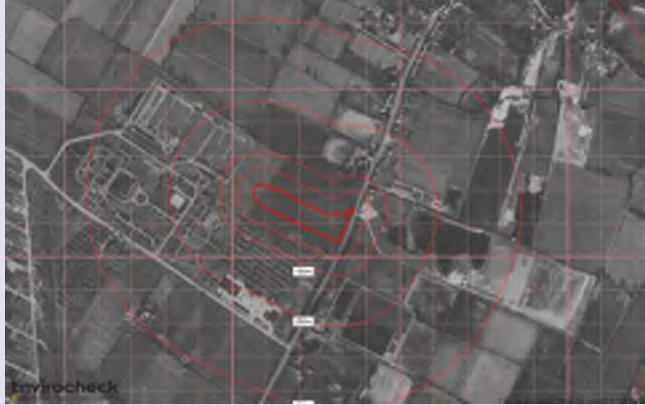
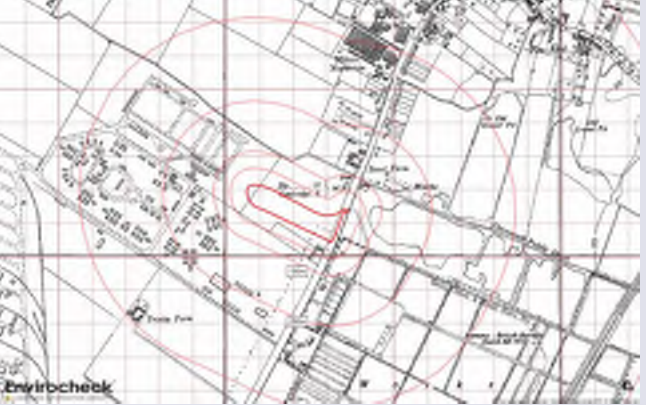
<p>1948: onsite: the western tip of the site appears to lie within a World War 2 military barracks, however no notable changes are shown within the site boundary.</p> <p>Offsite: a substantial military barracks including railway sidings is shown to the SW and several 'ponds' likely gravel pits are shown to the E and NE. The sewage Farm is also visible to the SE.</p>	<p>1959-1966: onsite: no notable changes.</p> <p>Offsite: the military barracks are first shown on the 1959 map and 'Old Gravel Pits' are now labelled to the NE. The village of Milton is extending S towards the site and potential residential houses are also shown in plots to the S of the site.</p>

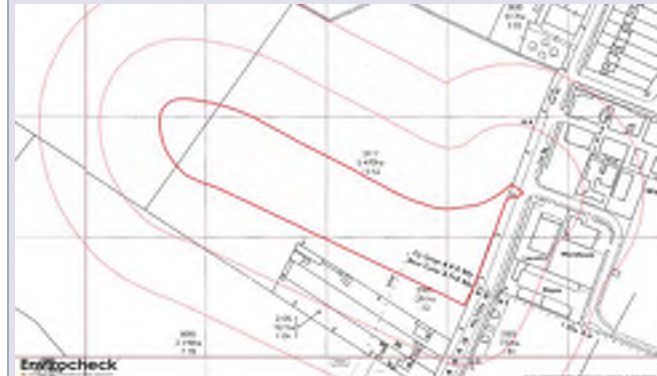
<p>1971/1972-1974: onsite: no notable changes. Offsite: The road immediately E of the site is labelled 'Milton Road'. Several warehouses and industrial type buildings (and a laundry) are shown E of Milton Road. A potential 'gravel pit/pond (75m E) is no longer shown (possibly infilled). The former tile works (160m NE) is simply labelled 'works'. Buildings on the former military barracks site are no longer shown, two round tanks are labelled within the former barracks site.</p>

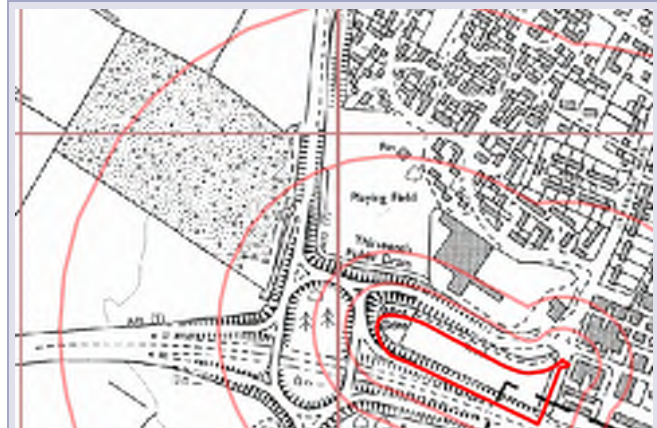
<p>1990-1992: onsite: the western end of the site is labelled 'allotment gardens' and a track is shown along the northern boundary between the allotments and site access in the NE. Offsite: a 'refuse tip' is labelled less than 200m NW (1990). A new superstore, fuel station and roundabout are shown to the north (by 1992). The industrial estate to the E continues to expand (1990 and 1992).</p>

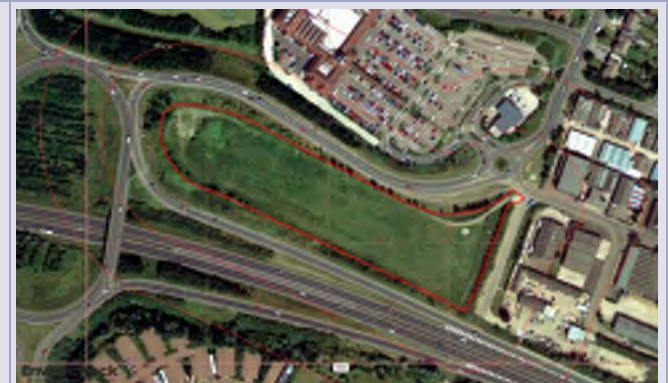
<p>1999-2000: onsite: no notable changes Offsite: parts of the landfill closest to the site are labelled 'tip disused' (2000), further west landfilling continued through 2000 and 2006 towards the area labelled 'recycling centre' 858m NW.</p>

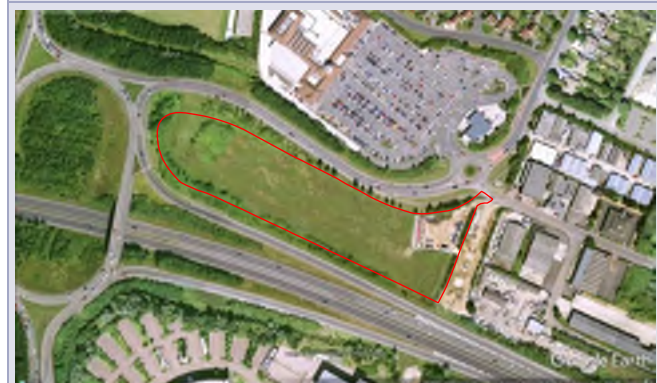
<p>2003: onsite: the eastern part of the site appears to form part of a temporary works areas (January 2003), possibly associated with construction of the Jane Coston Bridge which opened in May 2004.</p>

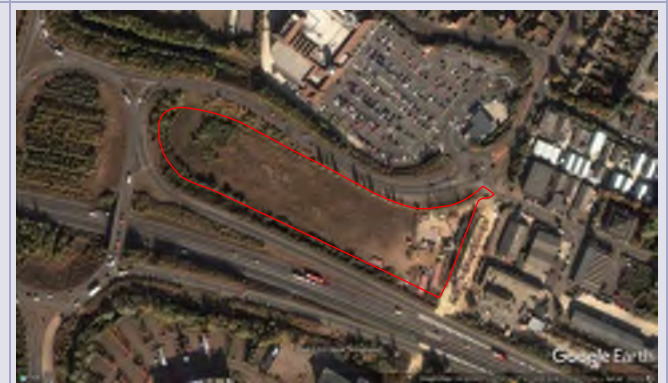
<p>2003: onsite: the temporary works area has expanded by October 2003.</p>

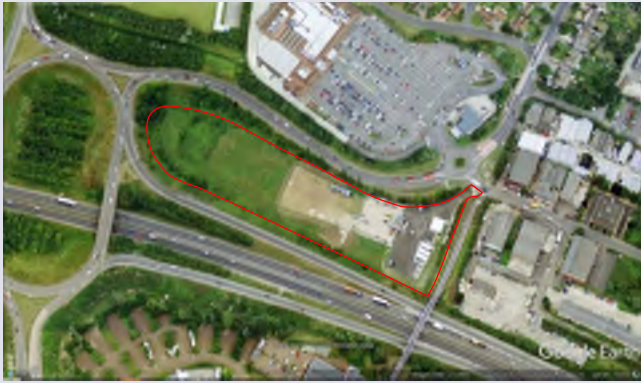
2005: onsite: approximately 60% of the site appears to be in use with areas of hardstanding and temporary buildings to the east, vehicles parked on site and storage areas to the west (January 2005).

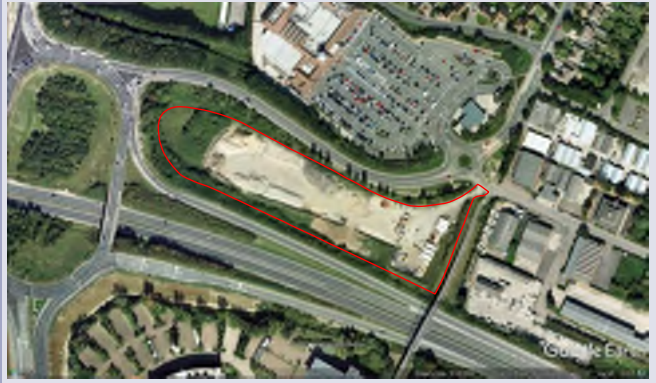
2006: onsite: the majority of the site is in use, potentially as a temporary works area associated with road/junction improvements which are in construction to the NW side of junction 33 on the A10. Several stockpiles are shown across the central and western parts of the site. Additional storage/temporary buildings are also shown in the east (October 2006)

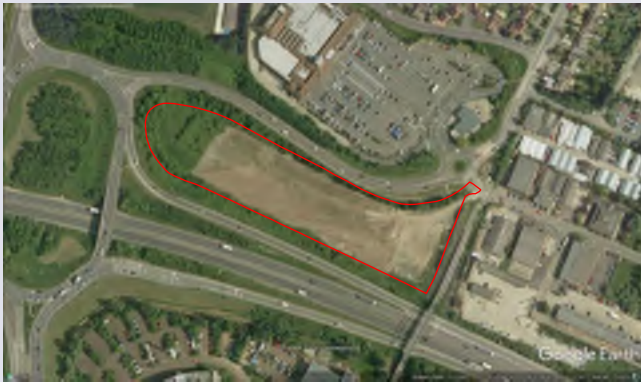
2007: onsite: the site appears to have been recently cleared with bare soil and vehicle track marks visible across most of the site (January 2007).

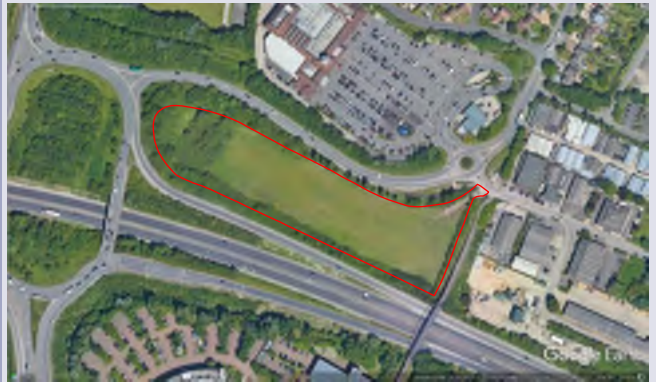
2017: onsite: the site appears to comprise open grassland again (May 2017).

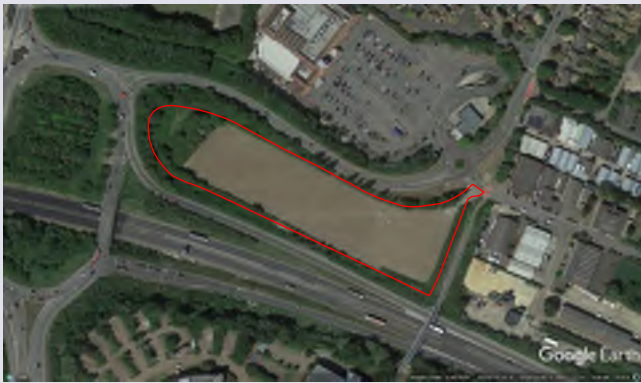
2020: onsite: the site appears to have been recently cleared with bare soil visible across most of the site (May 2020).

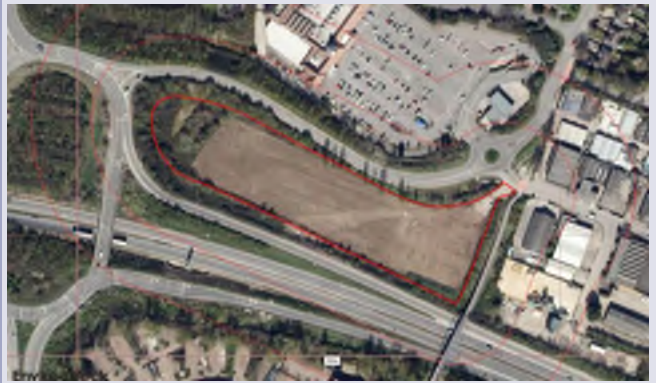
2021: onsite: No notable changes.

Offsite: the surrounding area has largely been developed, except for the landfill/former landfill site to the NW.

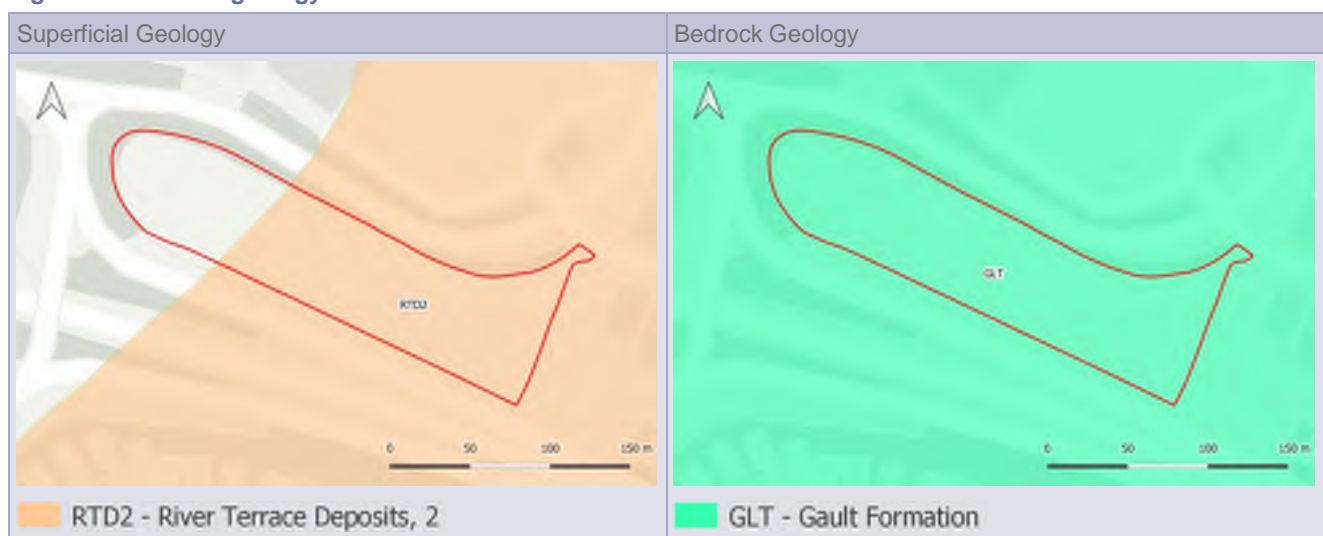
Figure 6 Published geology

The published geology of the area is shown on the geological map for Cambridge (Sheet 188), scale 1:50,000), published by the British Geological Survey (BGS), see Figure 6. Derivatives of the BGS mapping are included in the Geology Report (Landmark) and further geological information has also been obtained from the BGS website.

The geological mapping indicates that the site is underlain by the following sequence of superficial deposits and bedrock strata (the descriptions for each stratum are taken from the BGS):

- River Terrace Deposits (superficial deposits): comprising 'sand and gravel' are shown across the eastern two-thirds of the site. No superficial deposits are shown in the western part of the site.
- Gault formation (bedrock): "pale to dark grey or blue-grey clay or mudstone, glauconitic in part with a sandy base. Discrete bands of phosphatic modules (commonly preserving fossils) some pyrite and calcareous nodules".

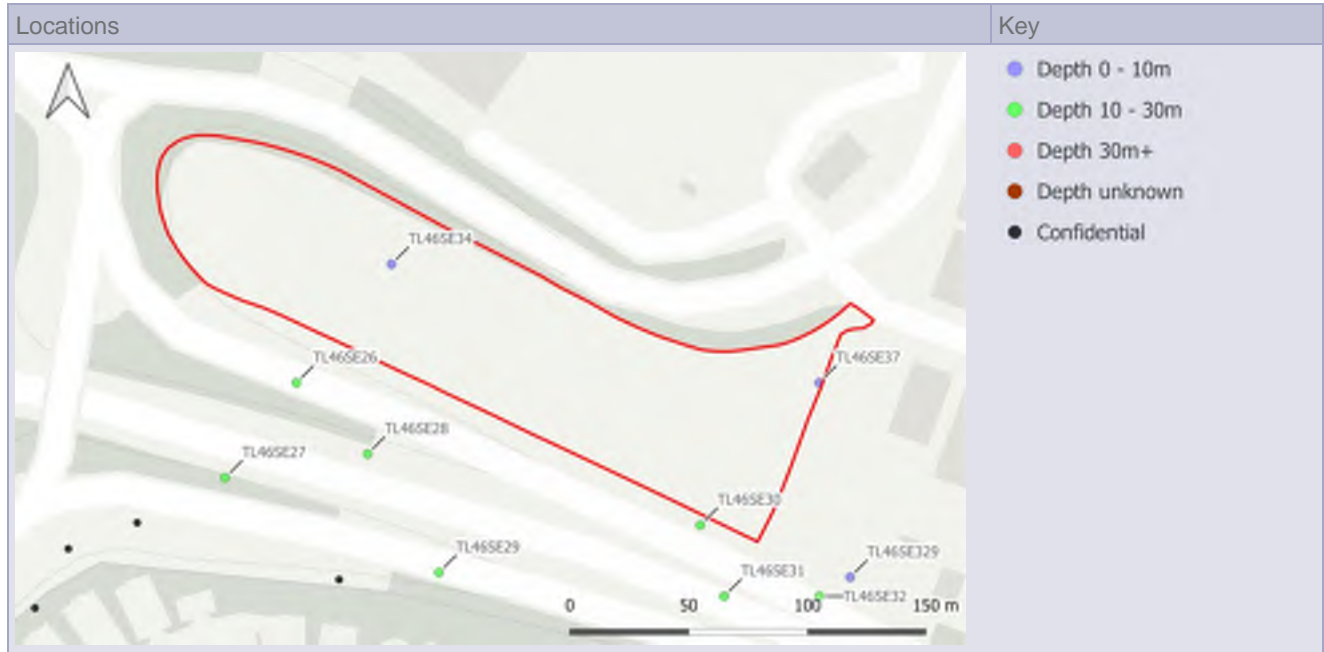
Figure 7 Historic borehole records

Figure 7. There are two records of historic boreholes within the site boundary, and an additional 11 records within 100m of the site (non-confidential records). The on-site borehole records indicate that in 1971 the site was underlain by up to 0.5m of topsoil over a medium-dense orange/grown 'sand and gravel' between 1.1 and 2.2m thick over 'stiff blue/grey mottled fissured silty clay'. These descriptions concur with the BGS recorded geology.

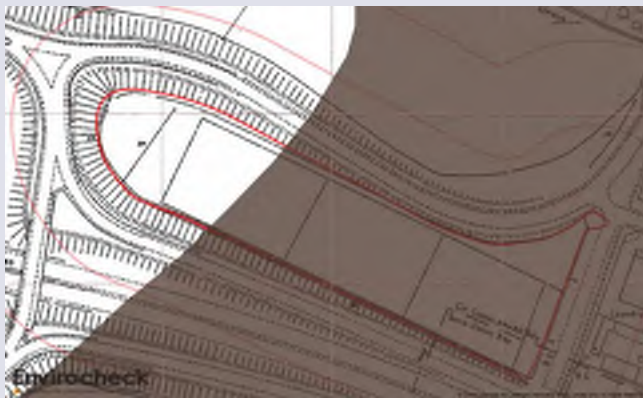
<p>Superficial aquifer classifications</p> <p>Principal Secondary A Secondary B</p>

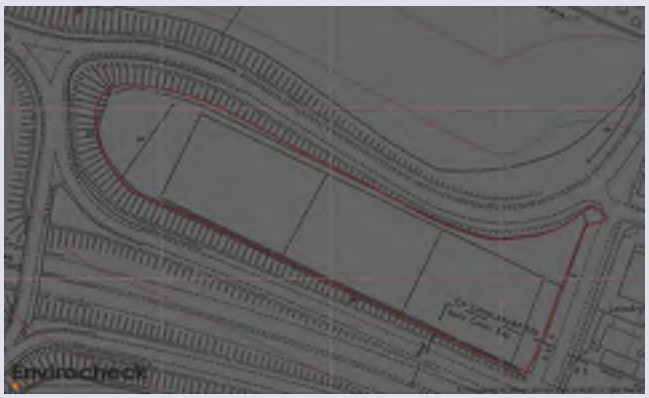
<p>Bedrock aquifer classifications</p> <p>Secondary Undifferentiated Unproductive Strata</p>

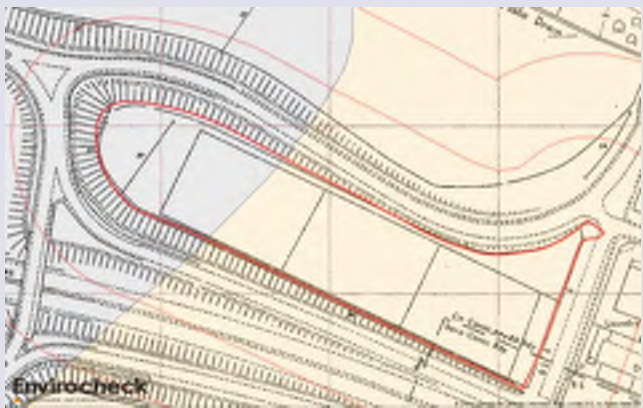
<p>Superficial Vulnerability</p> <p>Principal Aquifer High Medium Low</p> <p>Secondary Aquifer High Medium Low</p> <p>Unproductive Strata</p>	<p>Superficial vulnerability:</p> <p>High</p> <p>Areas able to easily transmit pollution to groundwater. They are characterised by high leaching soils and the absence of low permeability superficial deposits.</p>

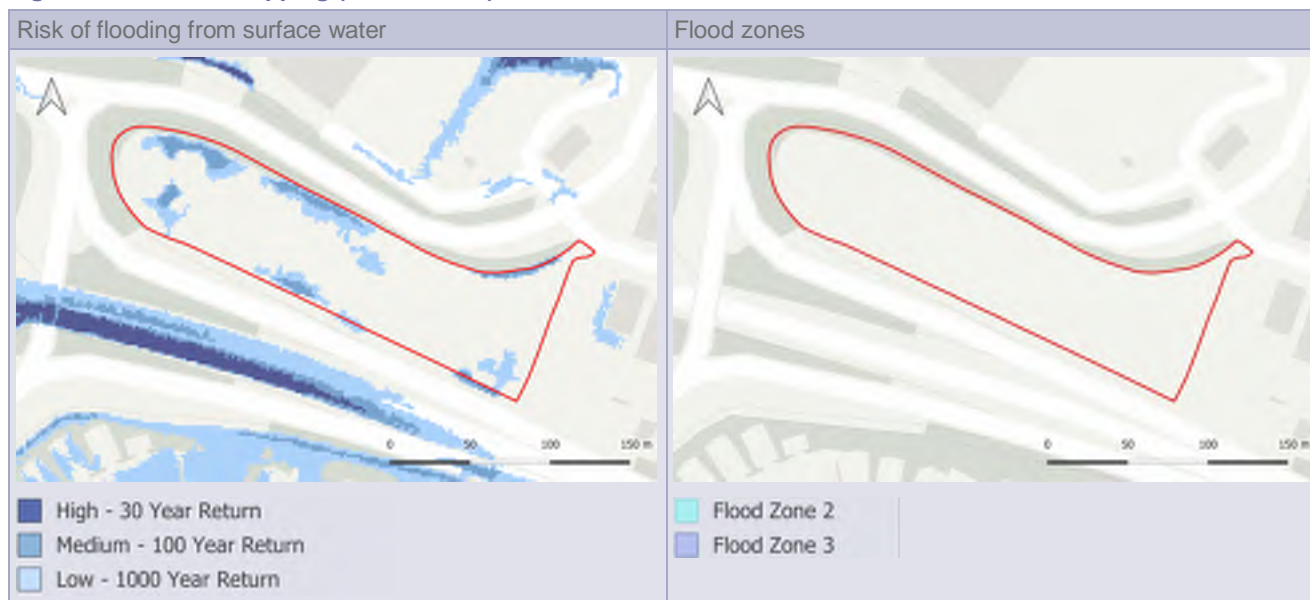
Figure 8 Flood risk mapping (Envirocheck)

The surface water flood risk maps (see Figure 8) indicates that there is a low to medium risk from surface water flooding towards the site perimeter adjacent to the toe of the road embankments. The site is not within an area benefiting from flood defences. The Envirocheck records indicate that the site is outside Flood Zones 2 and 3 (Figure 8).

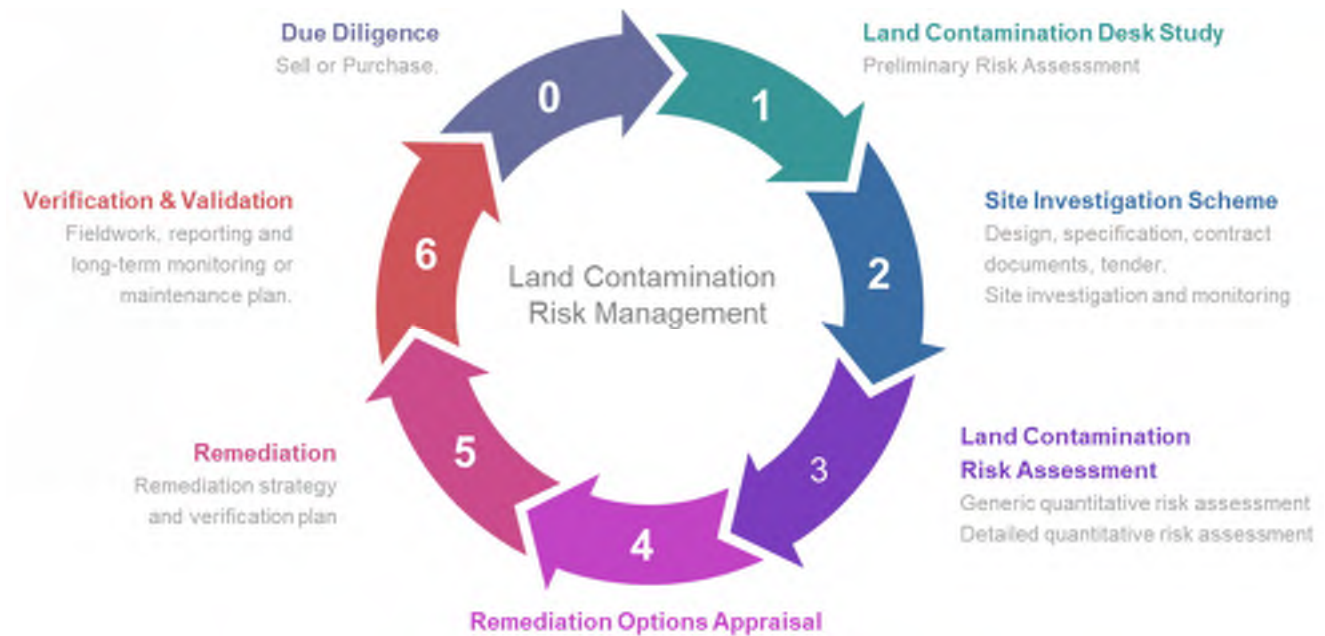
Figure 13 Land Contamination Risk Management process - simplified

As described in Section 4, a preliminary Conceptual Site Model has been developed to communicate and convey the *potential* Contaminant Linkages identified by the Land Contamination Desk Study (LCDS). The *preliminary* CSM will need to be updated as the proposed development progresses through the Land Contamination Risk Management (LCRM) process. Figure 13 presents a simplified summary of the LCRM process. Intrusive site investigation information is needed to 'test and refine' the CSM and monitoring can be used 'to validate' the CSM during the quantitative risk assessment stage of LCRM (3: land contamination risk assessment in Figure 13).

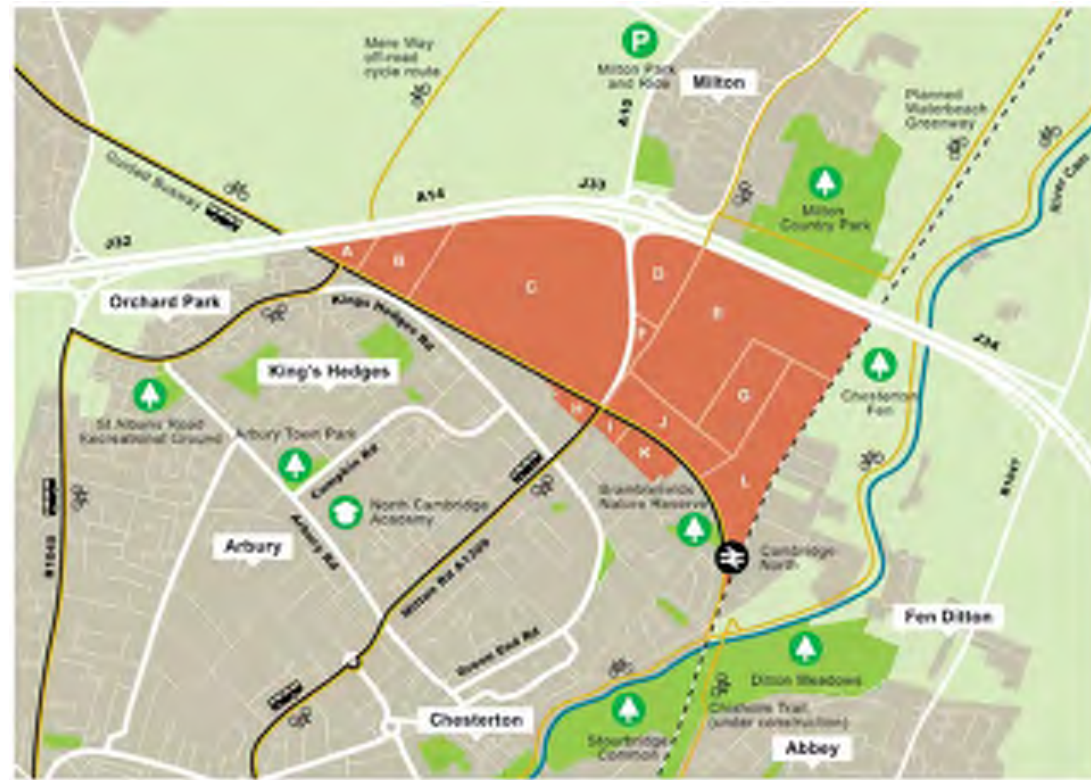
Figure 6: Land ownership within the Area Action Plan boundary

| F Merlin Place (private ownership) | L Chesterton Sidings (Network Rail) |
