SOUTH TRUMPINGTON

Heritage Statement

March 2025

MOLA code: P24-227 V4

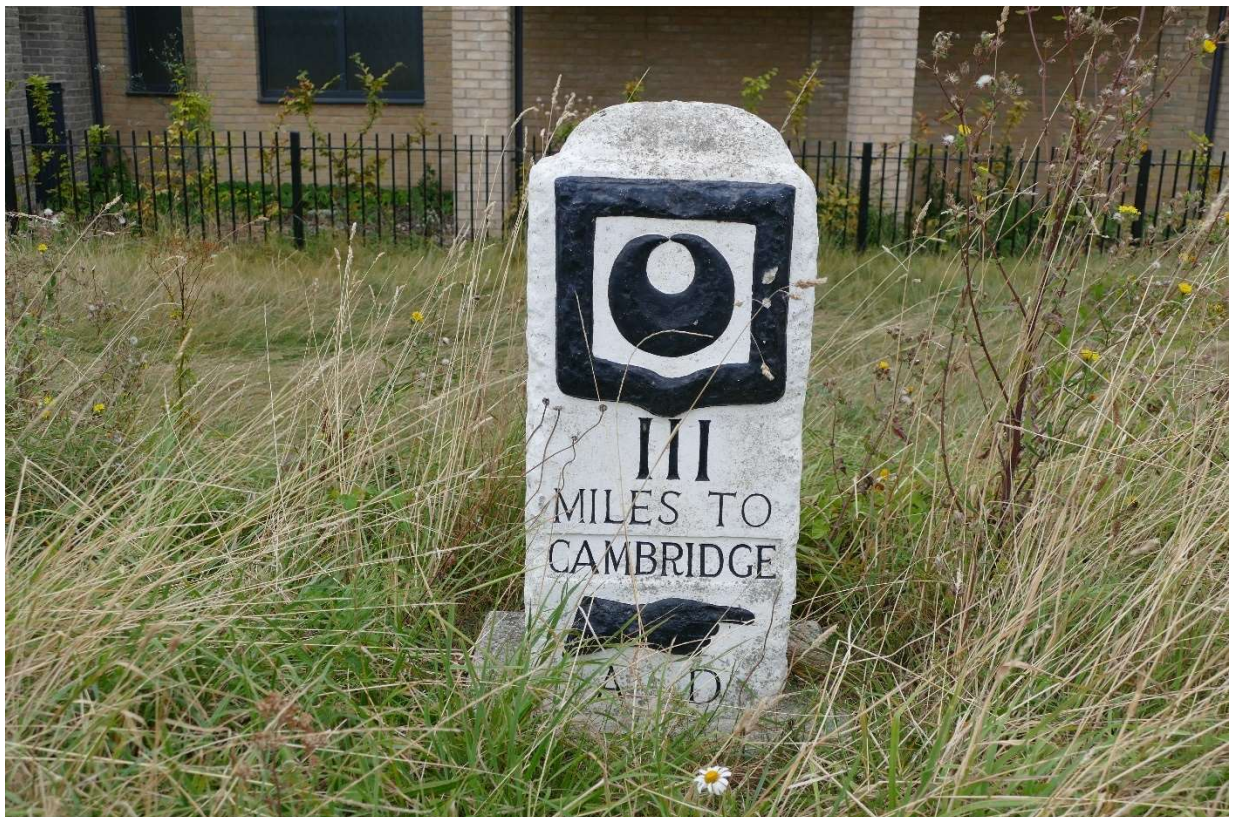
Figure 8: The Grade II Listed milestone facing Hauxton Road, looking west

- 5.2.7 The Grade II Listed milestone which stands c.76m to the north-east of the Site on Hauxton Road. It is the third of a series of 16 milestones placed beside the original road between Cambridge and London (which would become the modern A10), under the will of Dr. Mowse of Trinity Hall. The stone has been painted white and the lettering, benchmark, pointing hand and coat of arms of Trinity Hall are painted black. Since its restoration in 2000, the date of 1729 is now buried within the concrete plinth reducing its historical context to the passing readers.

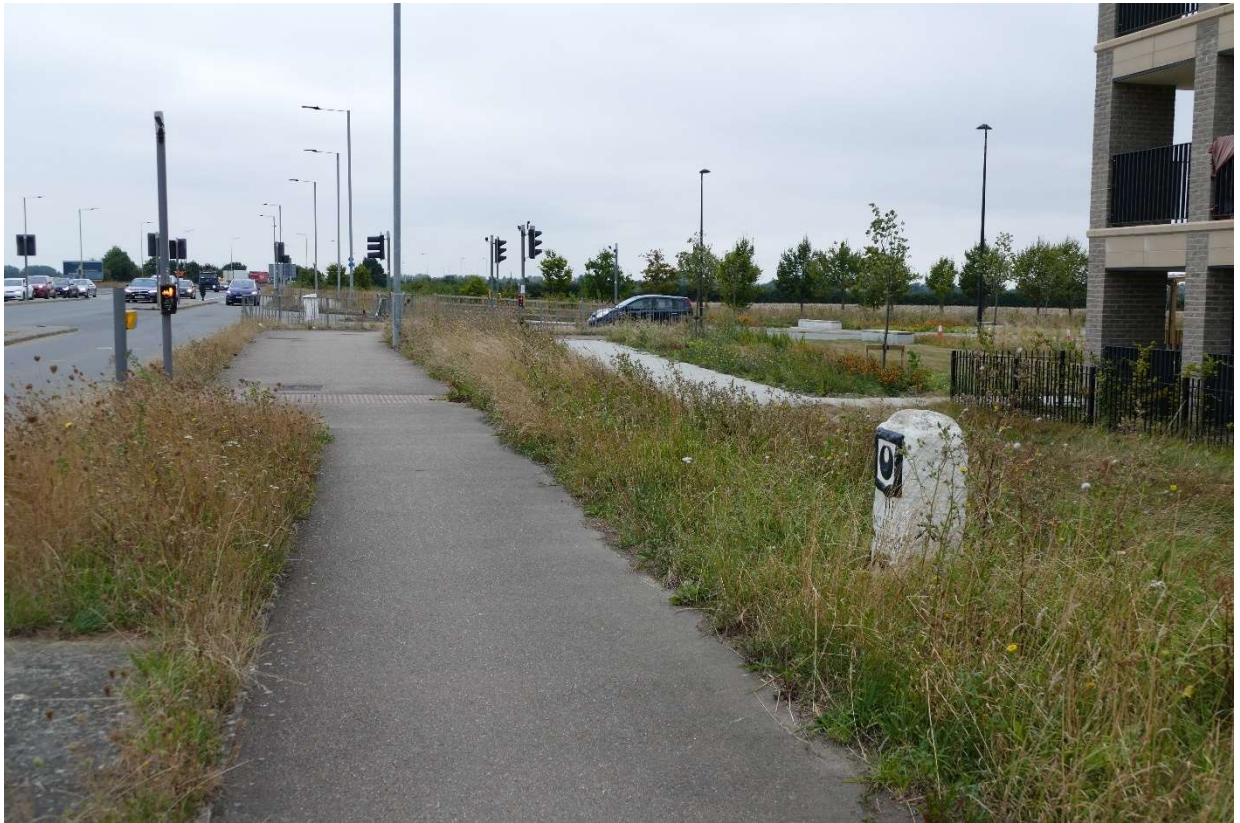
Figure 9: The milestone set within the context of Hauxton Road, looking south towards the proposed development (see Fig 2 for direction of view)

- 5.2.8 The milestone is set back several metres from the current Hauxton Road and separated by both the slip road to Trumpington Park and Ride and the footpath. According to historic mapping, the 19th-century Hauxton Road was less straight and the route has since been more or less adopted by the slip road that leads to Trumpington Park and Ride. Irrespective of the realignment of the roads, Hauxton Road provides the context and meaning through which the milestone can be read and understood. However, while a relationship between the two is still evident, in order to fully appreciate the milestone, one must be in close proximity to it; although painted black on white, its small size makes it less easy to see and understand from the east side of Hauxton Road. Therefore, the setting of the stone cannot be fully understood as such from more than a few metres away. Although the milestone belongs to a group of 16 along the A10, this is not evident on the ground because none are visible from the others.

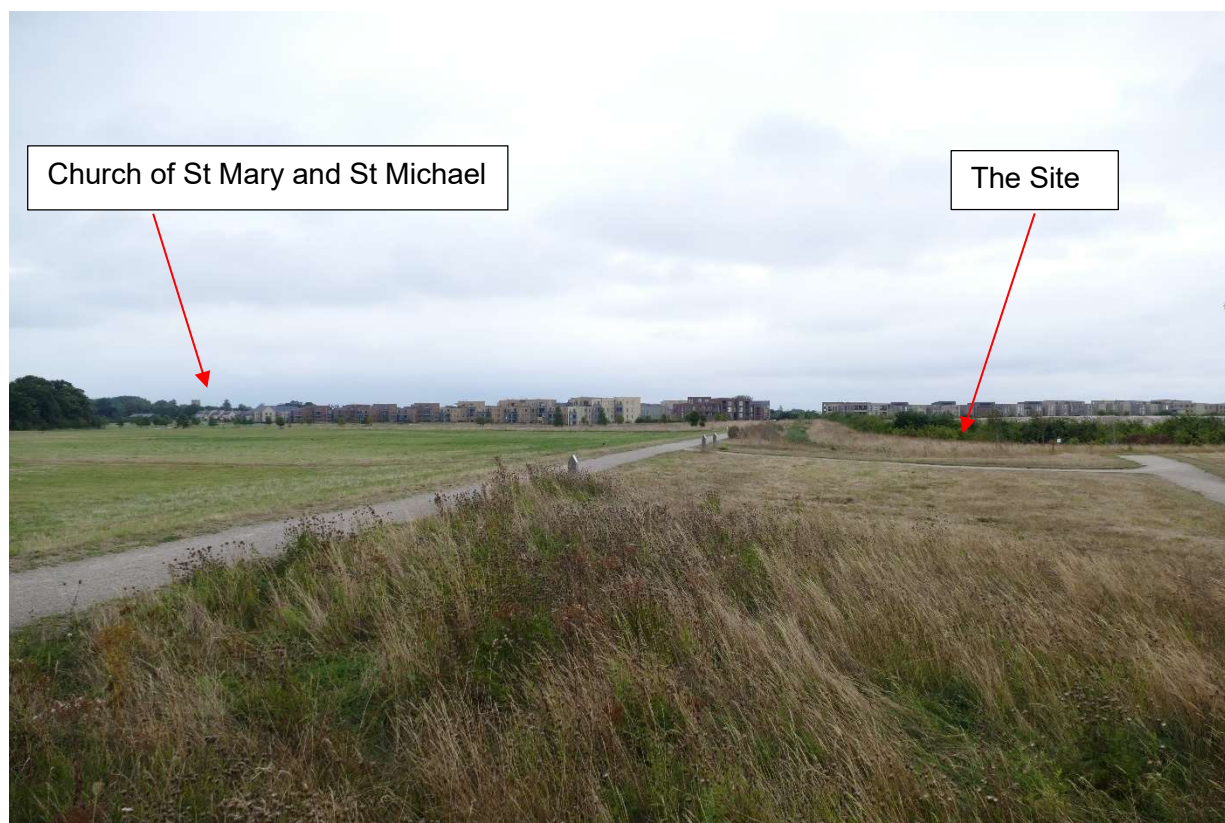
Figure 10: View across Trumpington Meadows, looking east (see Fig 2 for direction of view)

- 5.2.11 Only the top of the church tower is visible at points within the Site from the north-west and can be just seen above the treeline in the distance. The rest of the church is not particularly visible, unlike the open space in the foreground and the strong architectural rhythm of the recent development on the skyline.
